Chena River Lakes Project  
Fairbanks, Alaska

*Overview of Tanana River monitoring and  
research studies near Fairbanks, Alaska*

OVERVIEW OF TANANA RIVER MONITORING AND  
RESEARCH STUDIES NEAR FAIRBANKS, ALASKA  
(with Appendices)

Prepared by  
U.S. Army Cold Regions Research and Engineering Laboratory  
Hanover, New Hampshire

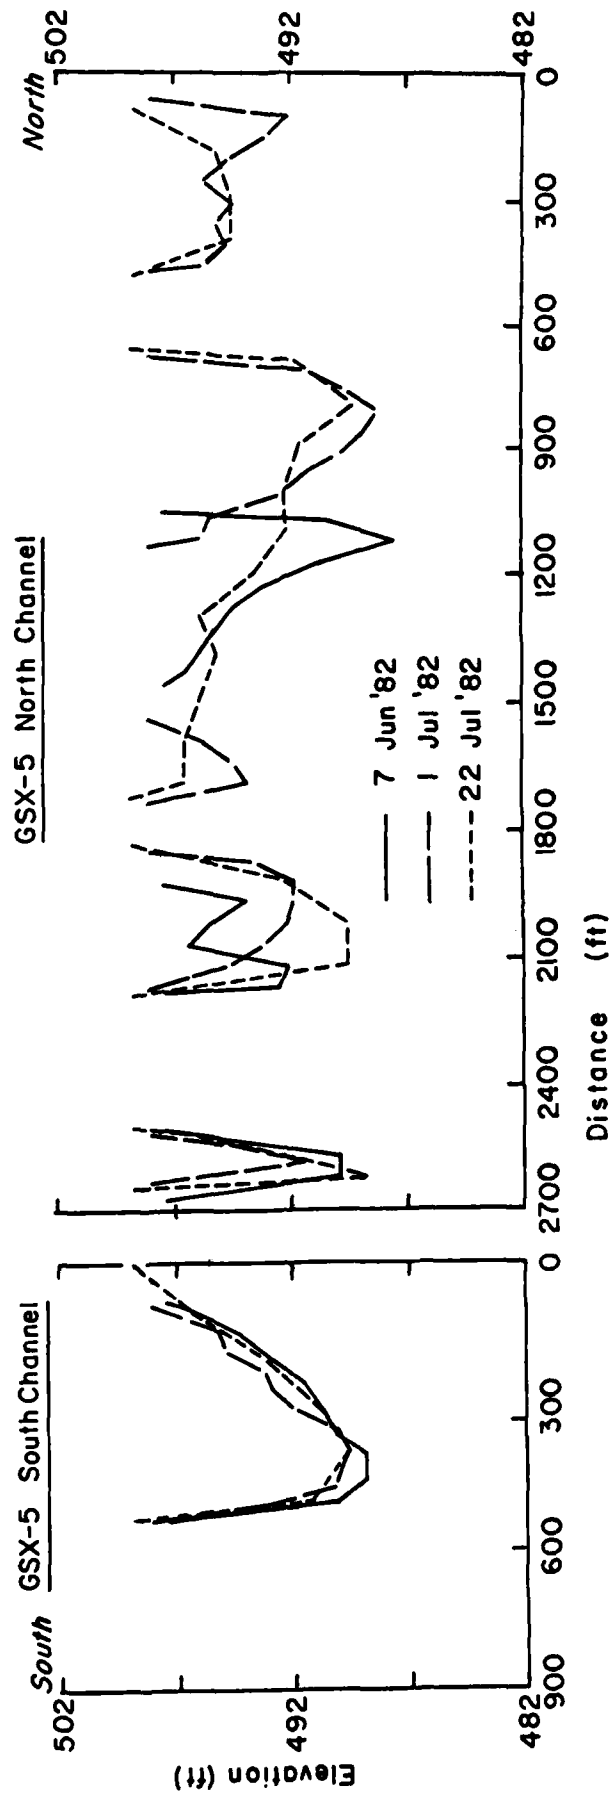
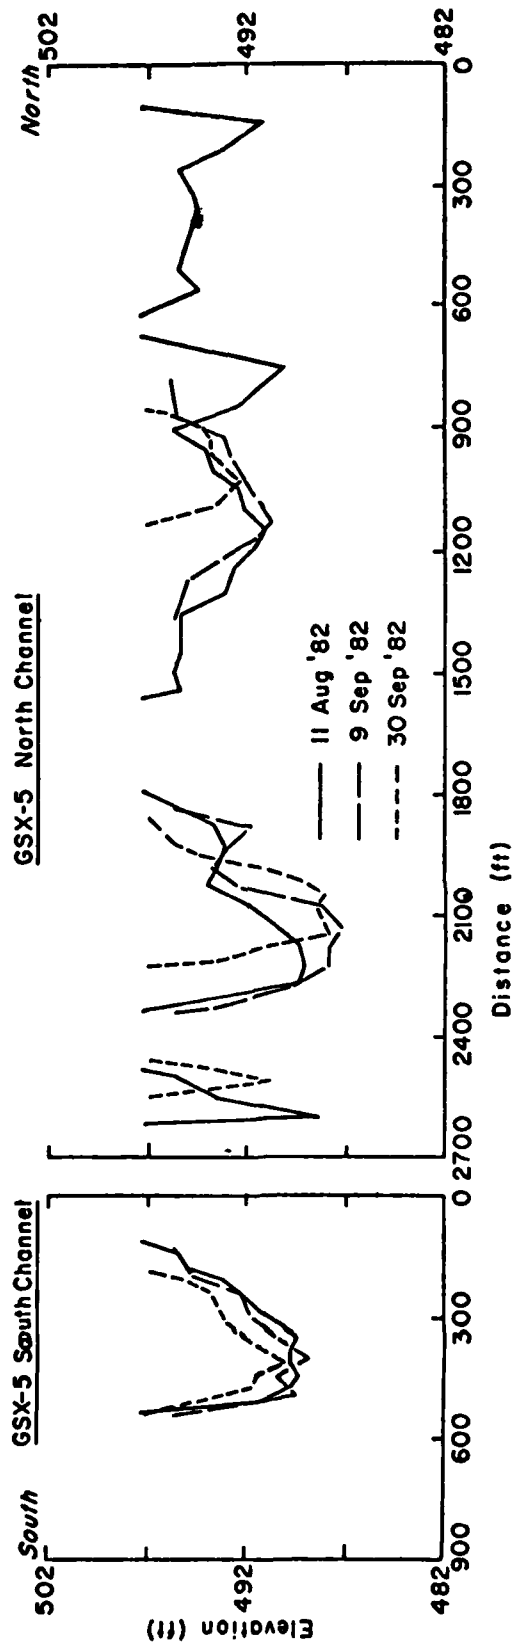
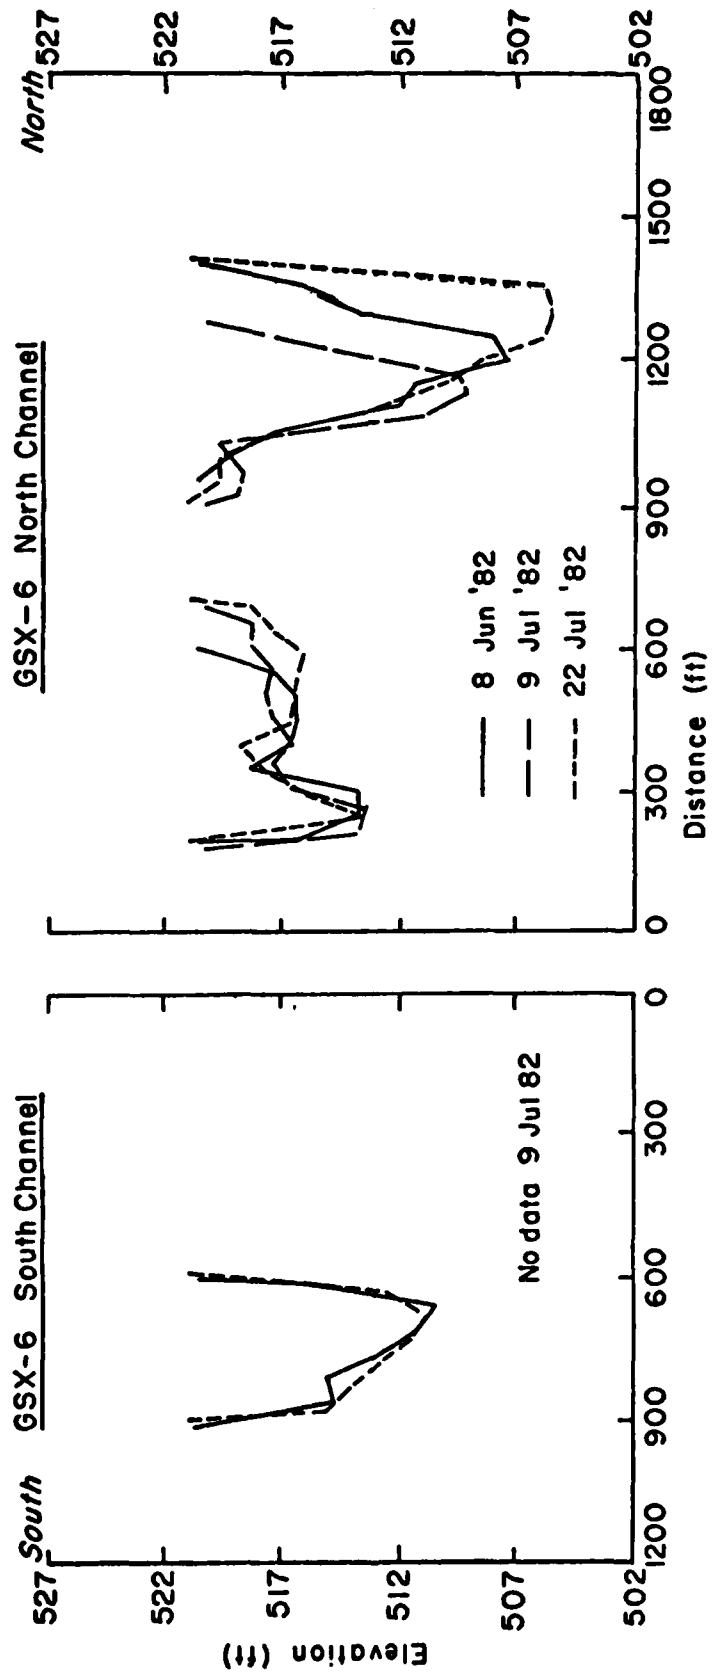
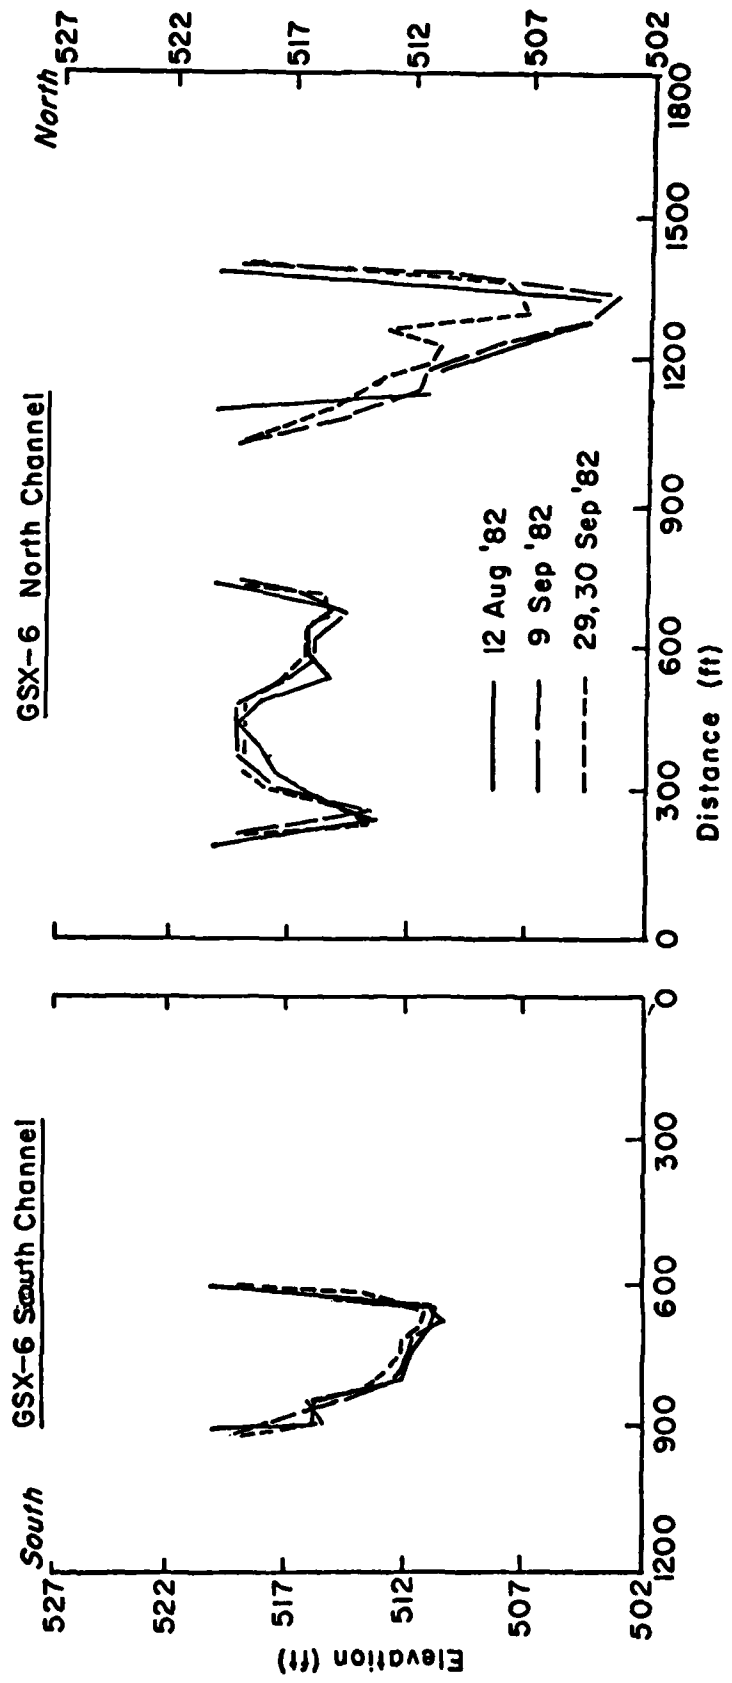
Figure 32. Cross-sections taken in 1982.

The cross-sectional changes that occurred in 1982 are as follows (Fig. 32). The south channel at GSX-5 showed minor changes and deposition occurred during the falling hydrograph. All the north channels showed large changes between surveys and large net changes for the season. Generally, there was a net shift to the north. The GSX-6 south channel showed little change. The north channels changed more during the rising hydrograph and showed a net northerly shift for the season.

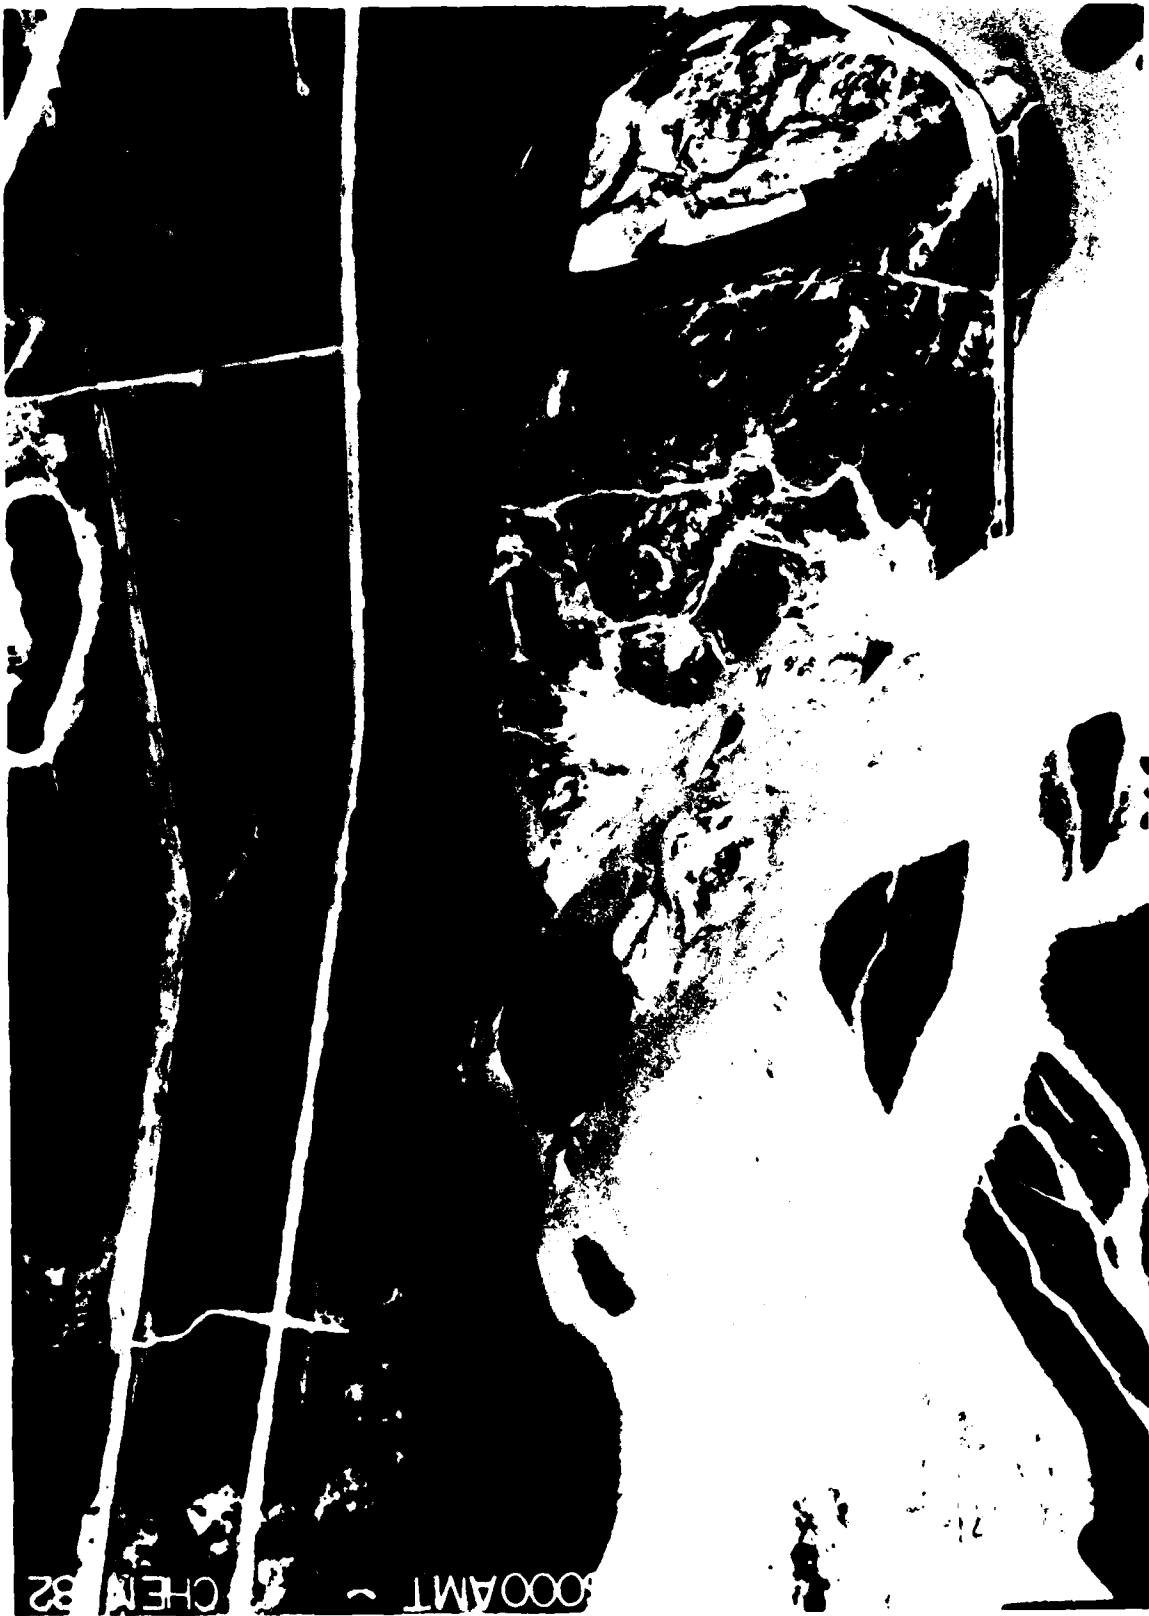
Figure 33. North Pole groin area, 4 June 1982.

Between May 1975 (Fig. 8) and June 1982 (Fig. 33) the channel migrated northeasterly into the groin and is eroding the eastern part of area 3 (Fig. 2). This trend may continue and the river could eventually erode through the islands and erode the north bank directly. Based on the observed historical recession rates and the position of the bank on 4 June 1982, the time required for the river to erode the north bank to the 500-ft safe zone along the levee was estimated based on historical trends.

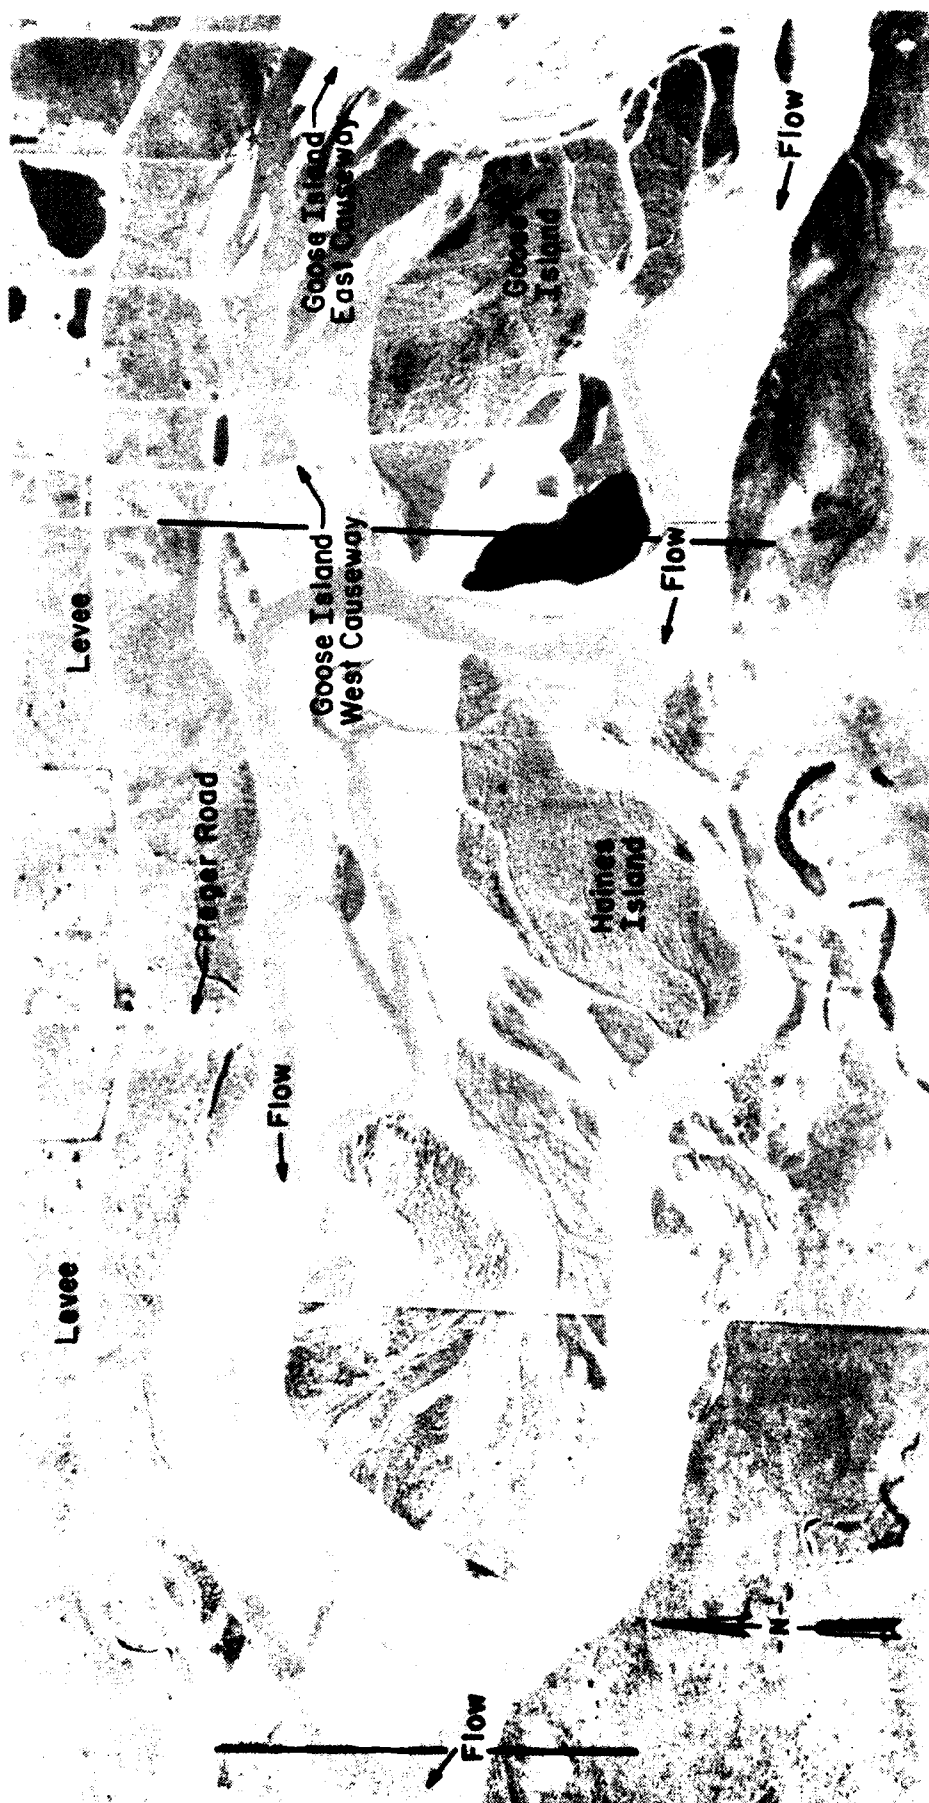
Figure 1. 7 May 1980 aerial photograph of study area.

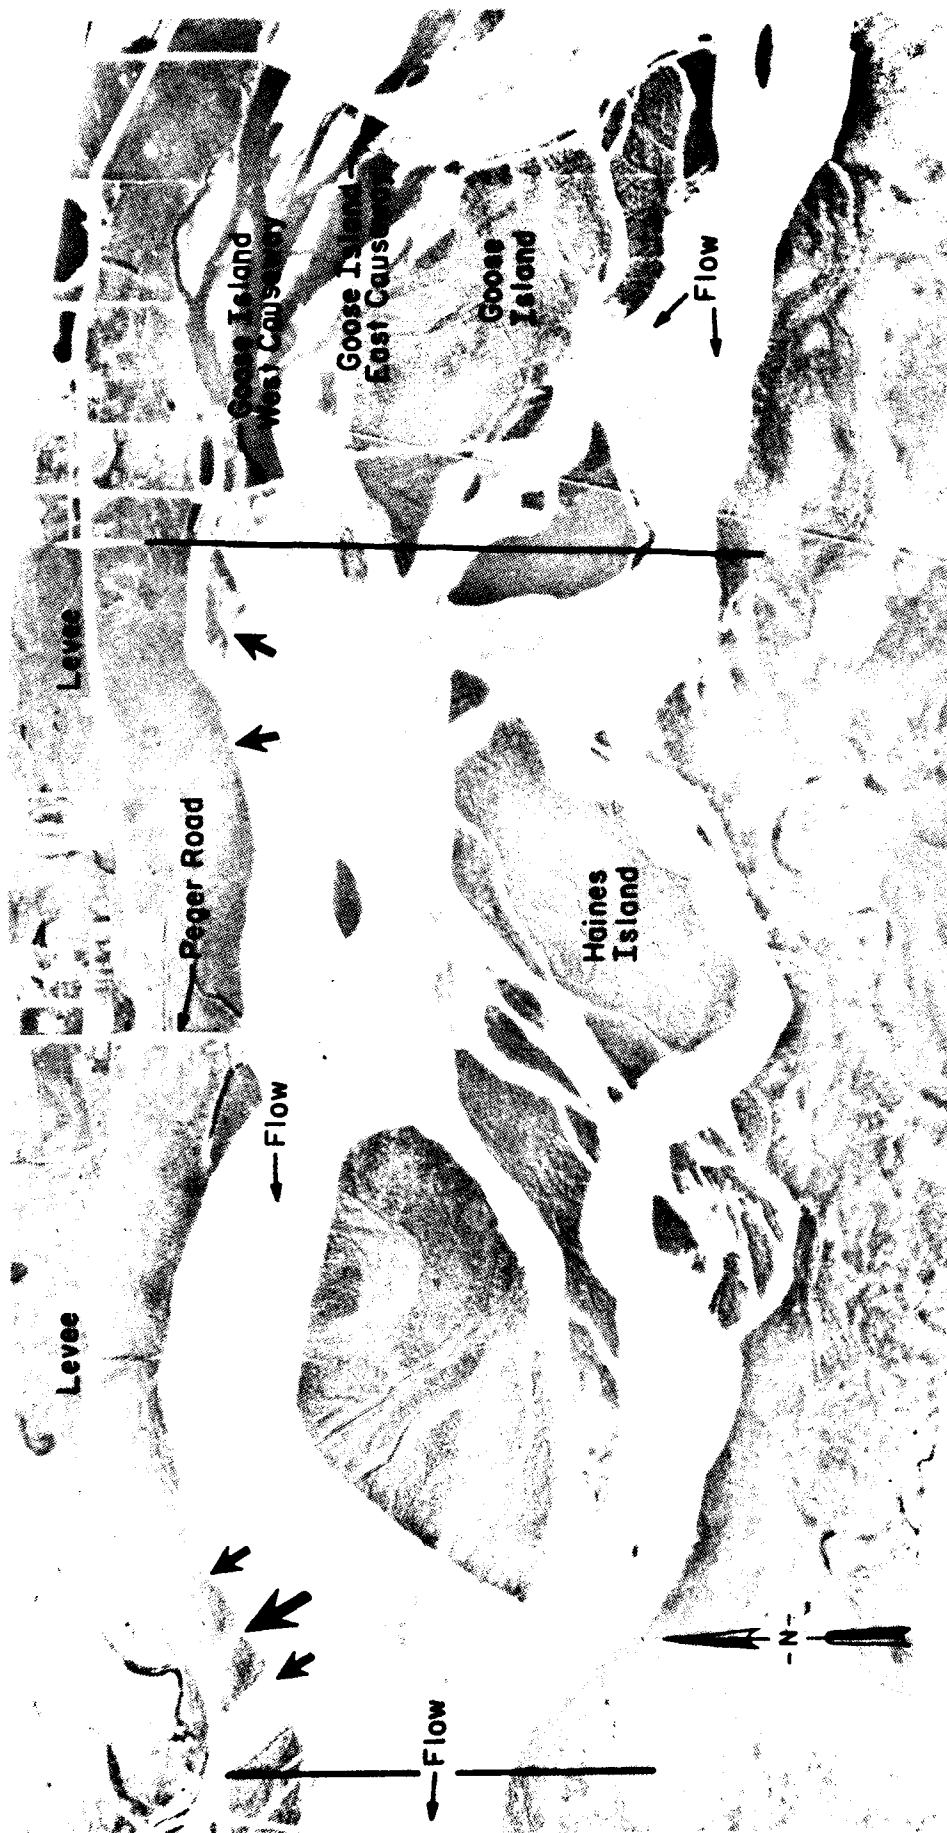
Figure 2. 4 June 1982 aerial photograph of study area.

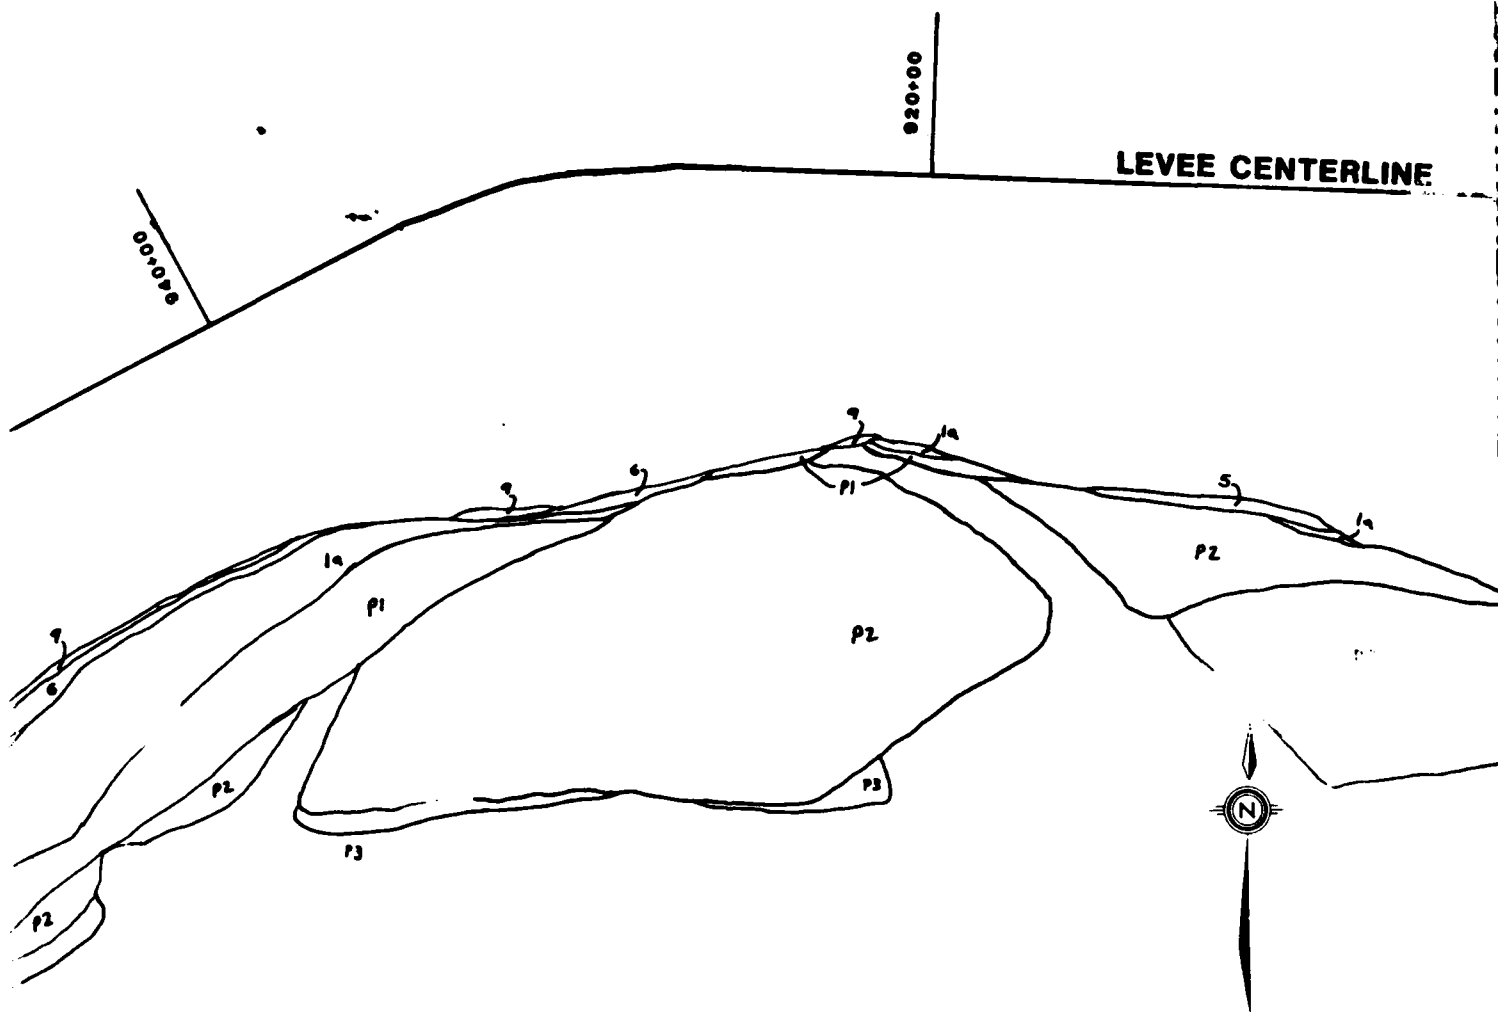
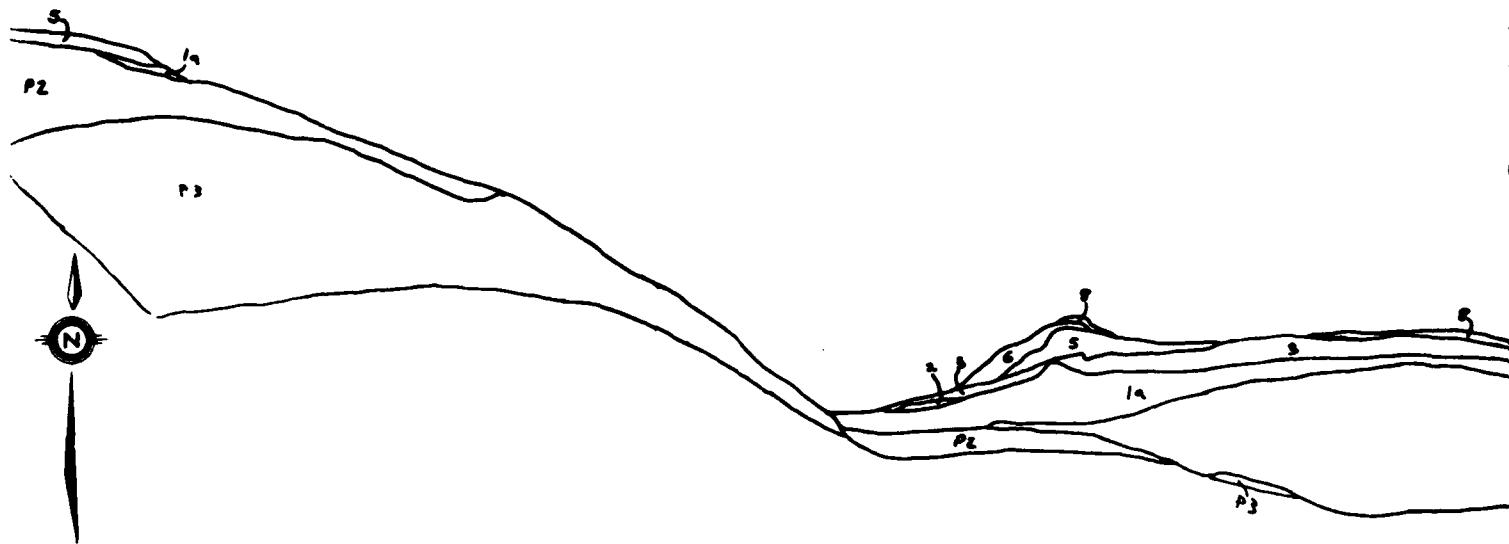
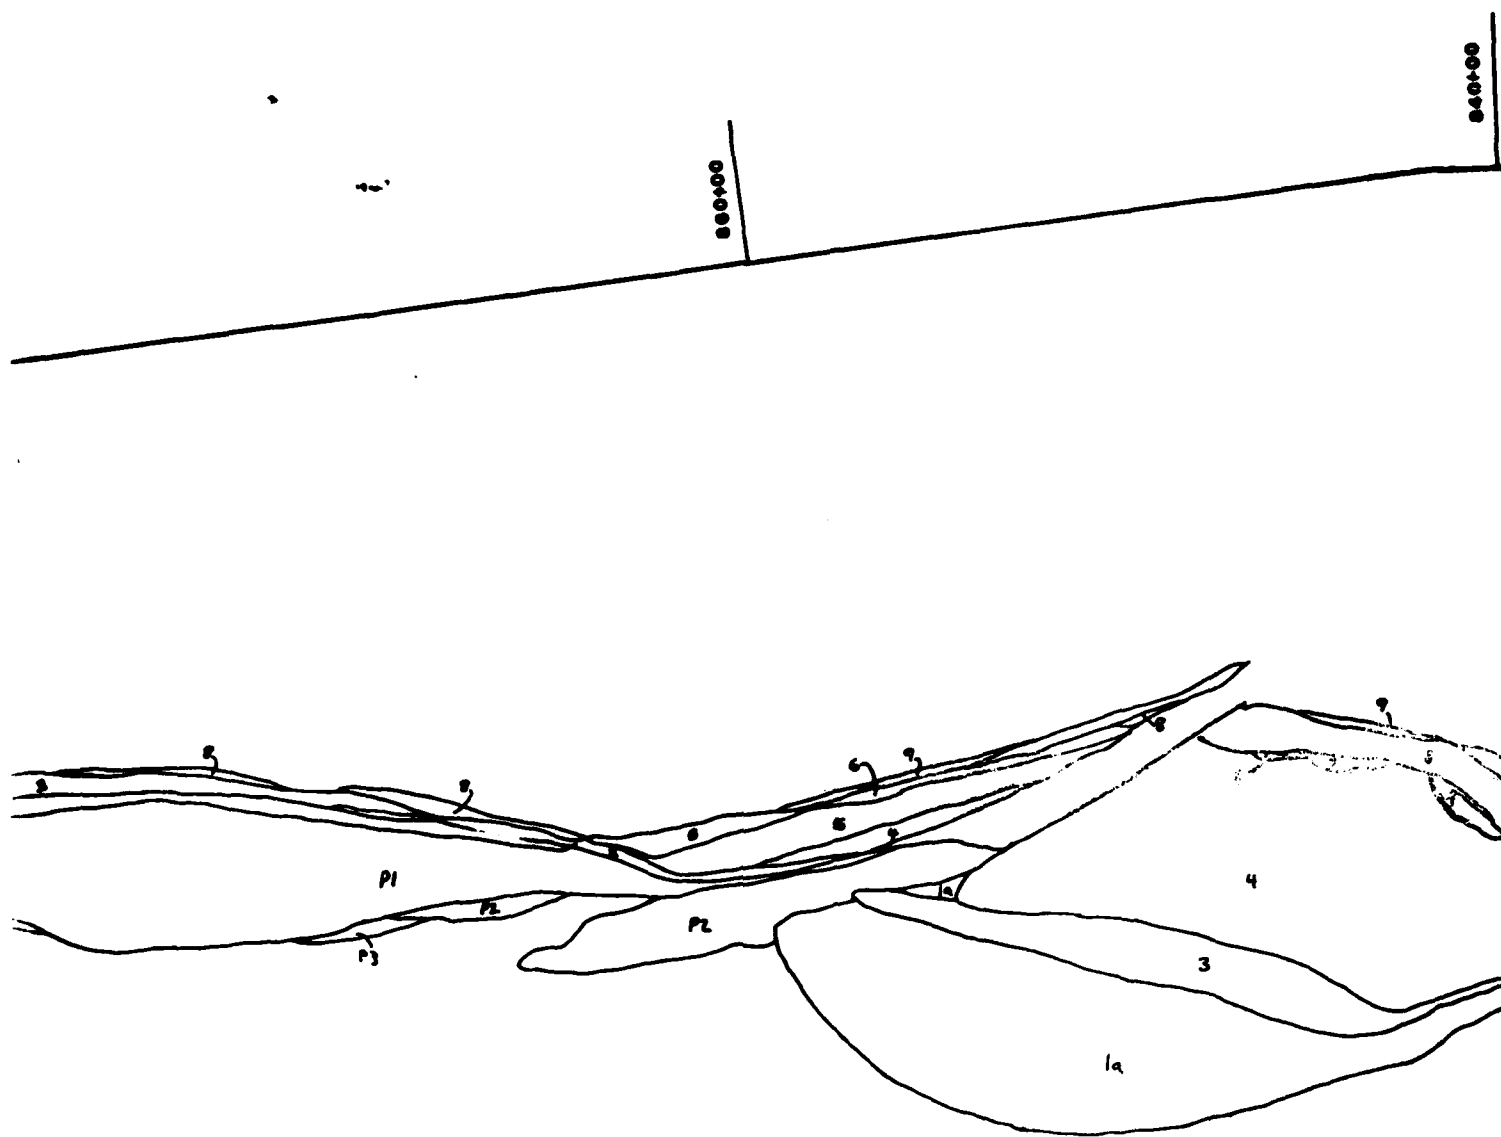
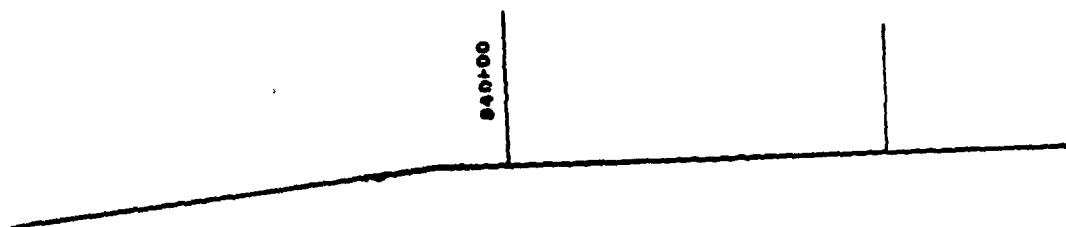
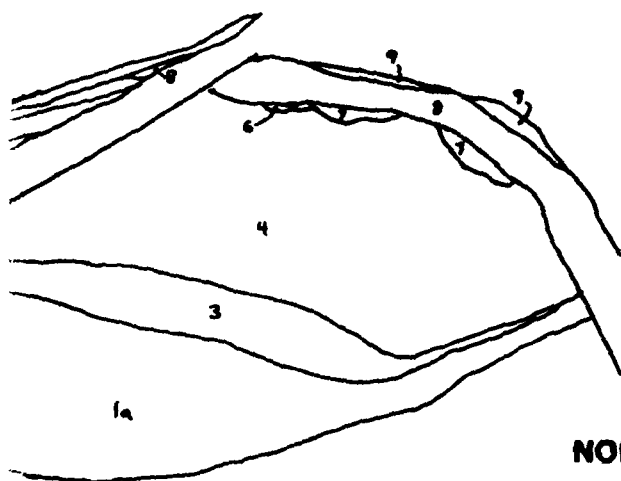
**FIGURE 3**

**NORTH BANK EROSION, TANANA RIVER  
FIRST DEFERRED CONSTRUCTION AREA**

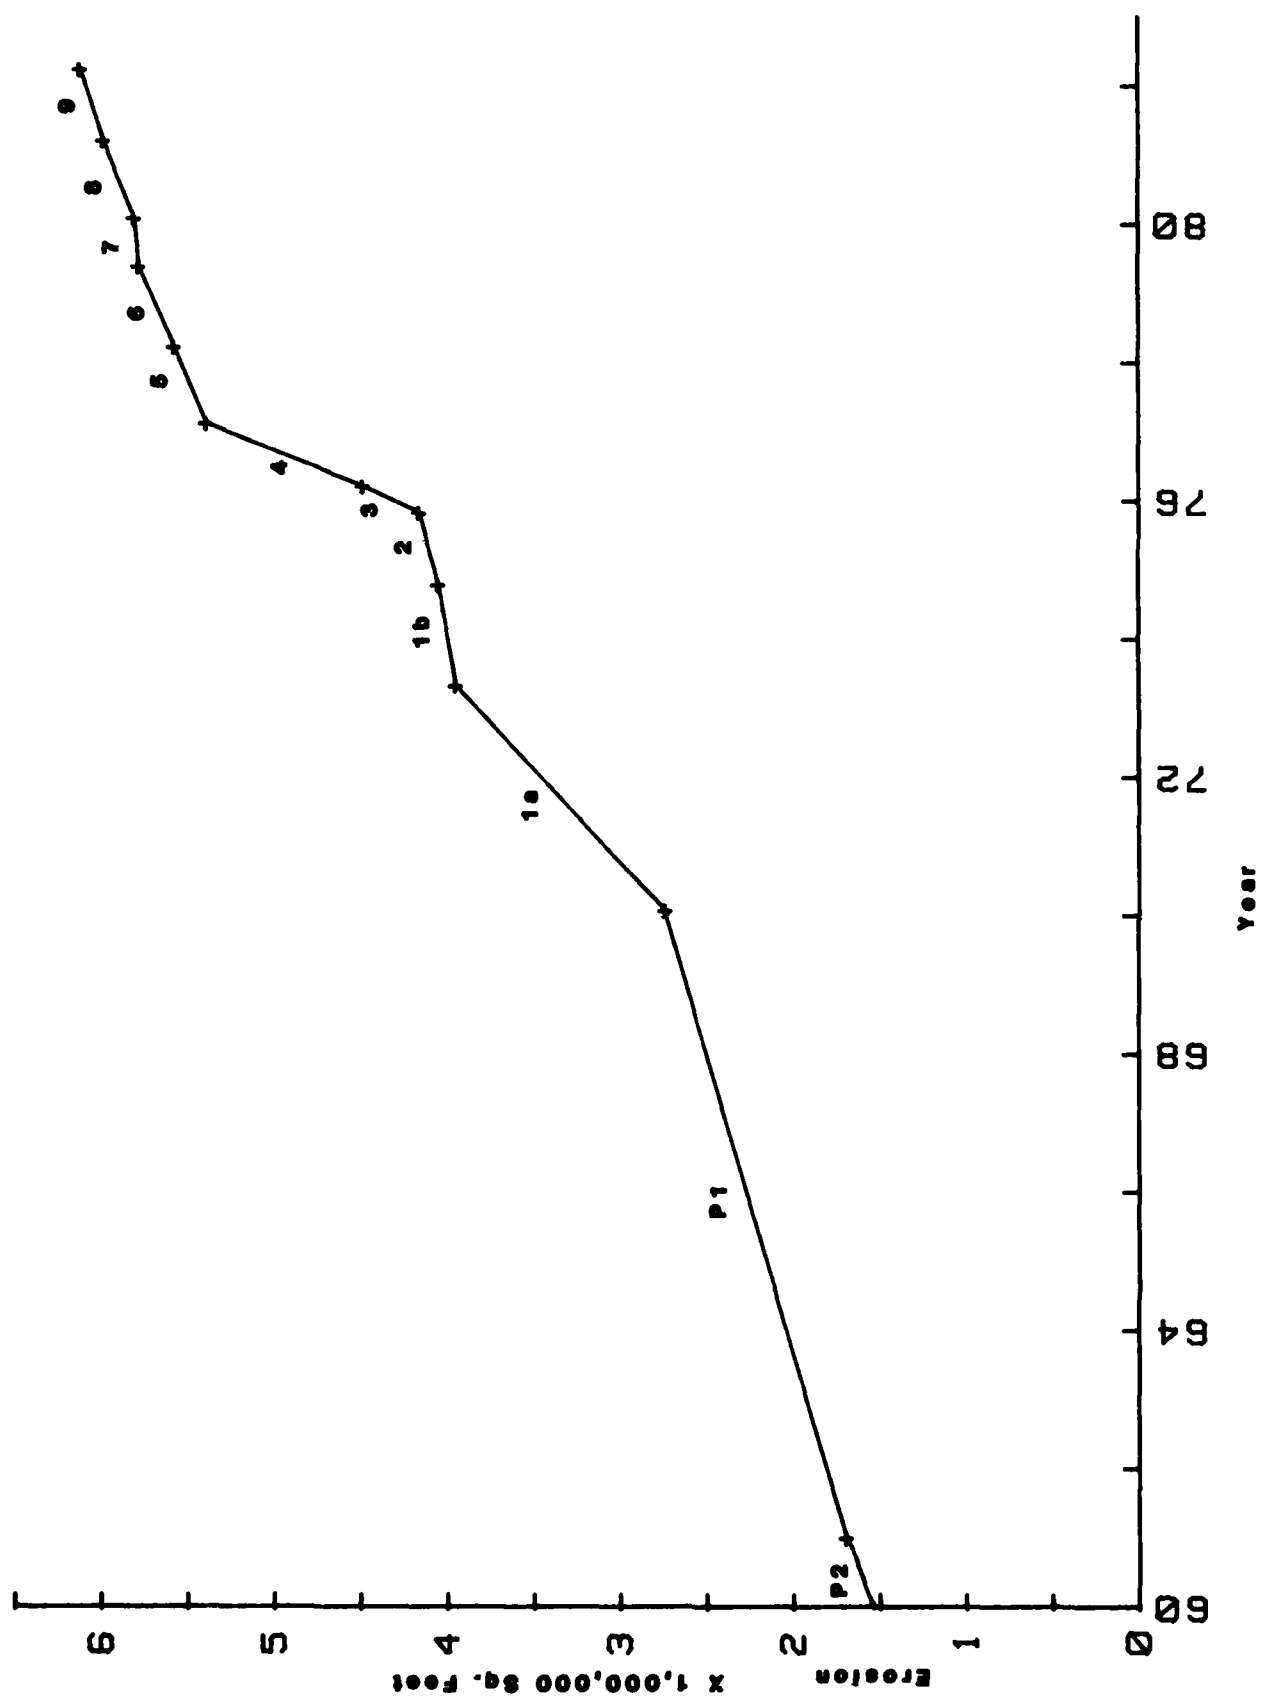
Figure 4. North bank cumulative erosion.

Figure 4 is a graph of the cumulative erosion that has occurred on the north bank over the last thirty-four years. The sharp increases in erosion during periods 1 a and during period 3 and 4 are apparent. It is unclear what caused the increase erosion during period 1a except that part of it was in a less resistant, partially vegetated former bar area. However, a large amount of the erosion occurred in a heavily vegetated bank area in the western bend. As pointed out before, periods 3 and 4 immediately follow the blocking off of the north channel behind Goose Island and may reflex the readjustment of channel patterns around Goose Island. Total erosion of 6,102,000 square feet has occurred over 34.00 years giving a long-term erosion rate of 179,000 square feet per year.

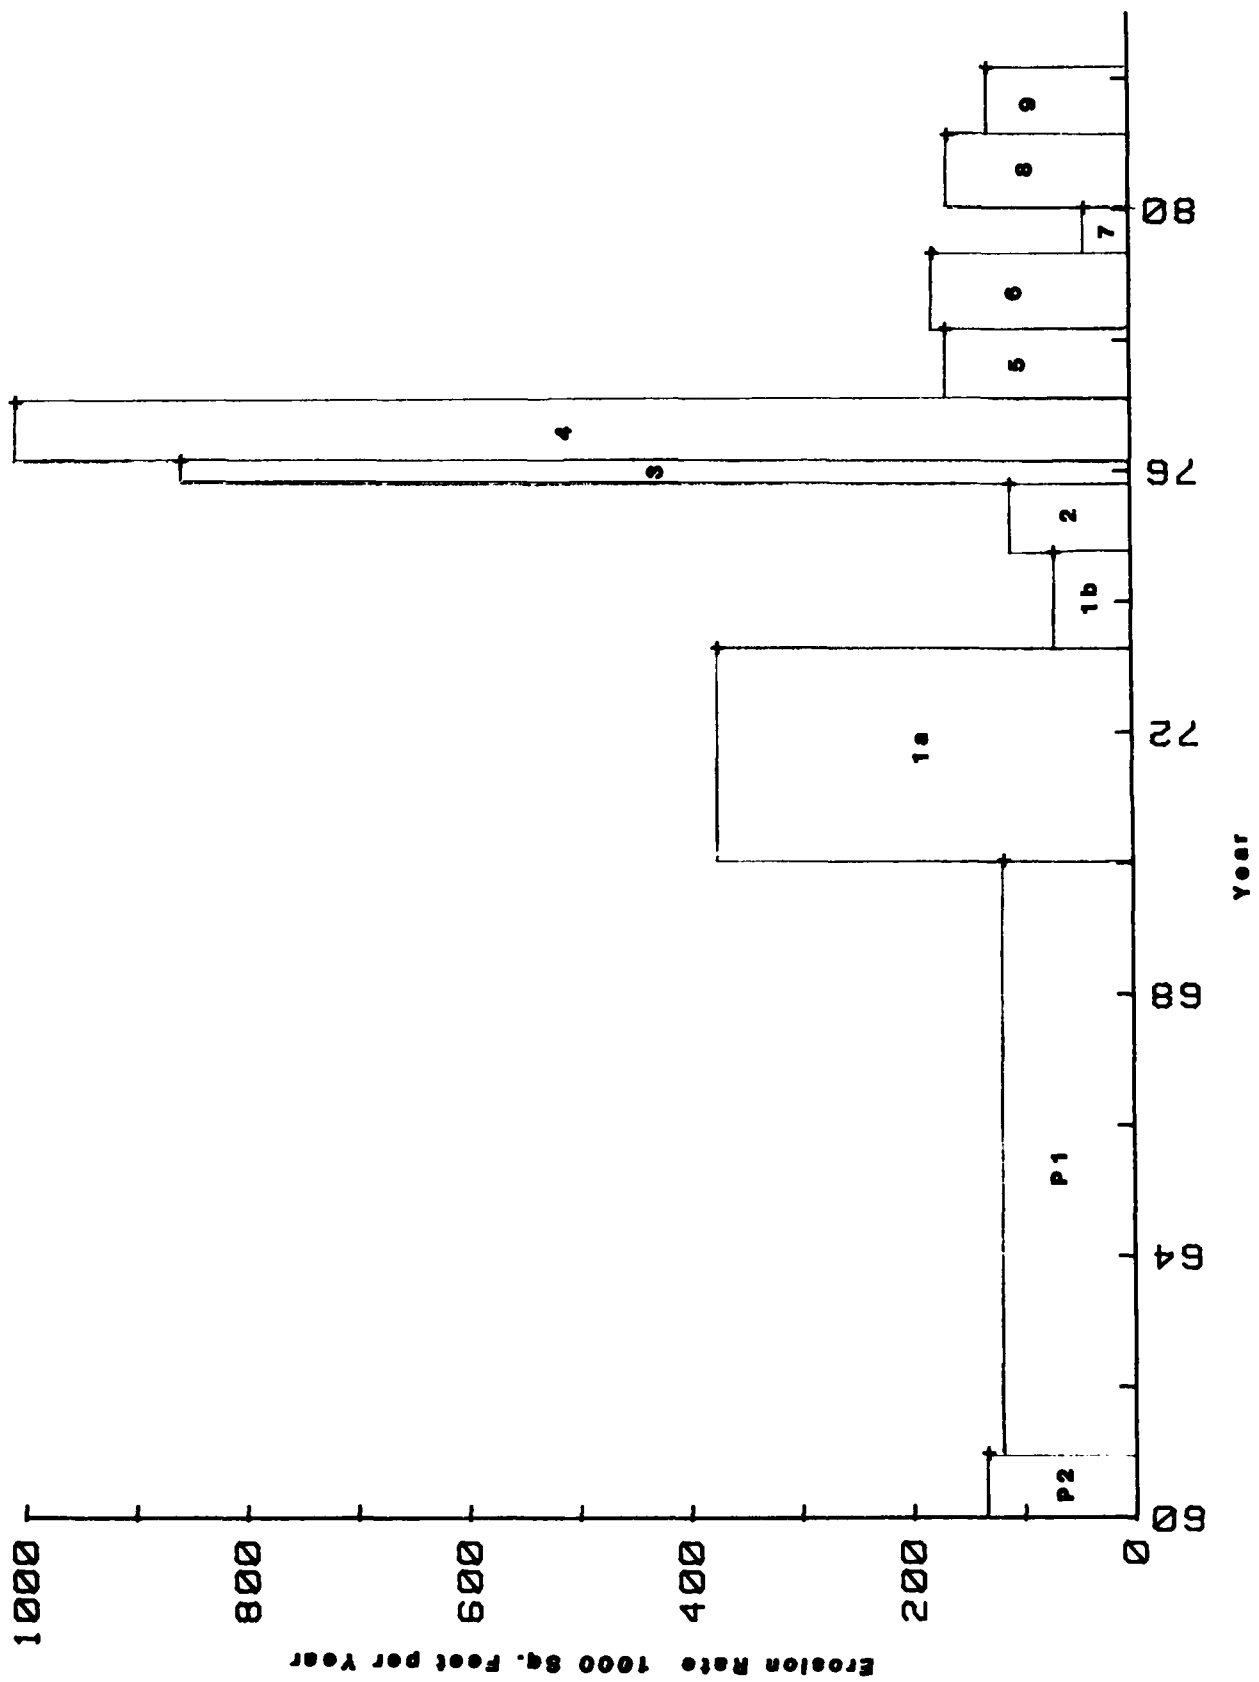
Figure 5. North bank erosion rates.
